# Manhole Inspection Summary

Manhole # S53C\_\_054MH

Insp Date: **6/19/08 2:00 PM**

**Location** Address: **rear 4 n clinton st**

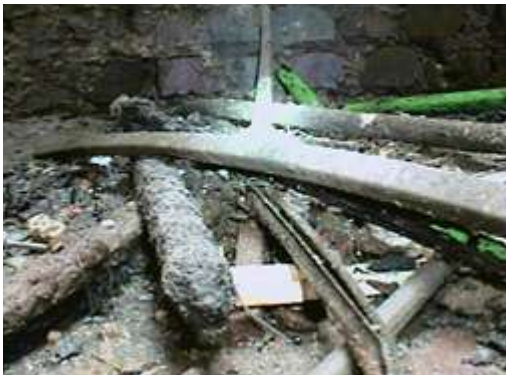
Defect 3

Condition: ☐ Sound ☐ Cracked ☐ Root Intrusion ☐ Deteriorated ☐ Leaks ☒ **Debris**

channel debris

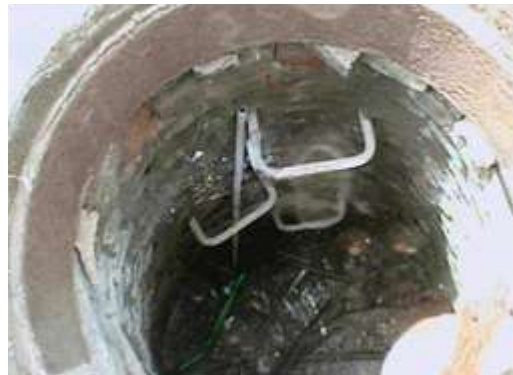
Defect 2

**Steps** Count: **3** Missing: **0** ☒ **Corroded**

steps

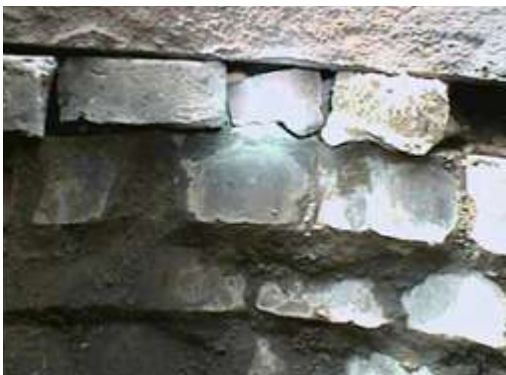
Defect 1

Condition: ☐ Sound ☒ **Cracked** ☐ Root Intrusion ☒ **Loose Brick** ☐ Deteriorated

chimney loose bricks, cracked, frame adj
